**Process Monitoring.** A new on-line inspection system for non-contact quality control during the manufacture of fiber-reinforced polymer structures can pick up problems early and thus reduce scrap rates. The measurement head at the heart of the system inspects the surface of the part under test with a camera whilst an integrated laser light section sensor acquires its geometry.

# Looking Right into the Texture

The InnoNet project Falcon (Fiber Automatic Live Control) has taken up the second challenge, that is the automation of the quality control (see box on the next page). Within this project an on-line inspection system for the automation of quality control during the manufacturing process of fiber-reinforced plastics (FRP) was developed. At the heart of this innovative system is a measurement head comprising an optical camera and a laser light section sensor. This combination allows for non-contact quality control: Whilst the camera inspects the surface the laser light section sensor acquires the geometry of the part under test (Fig. 1).

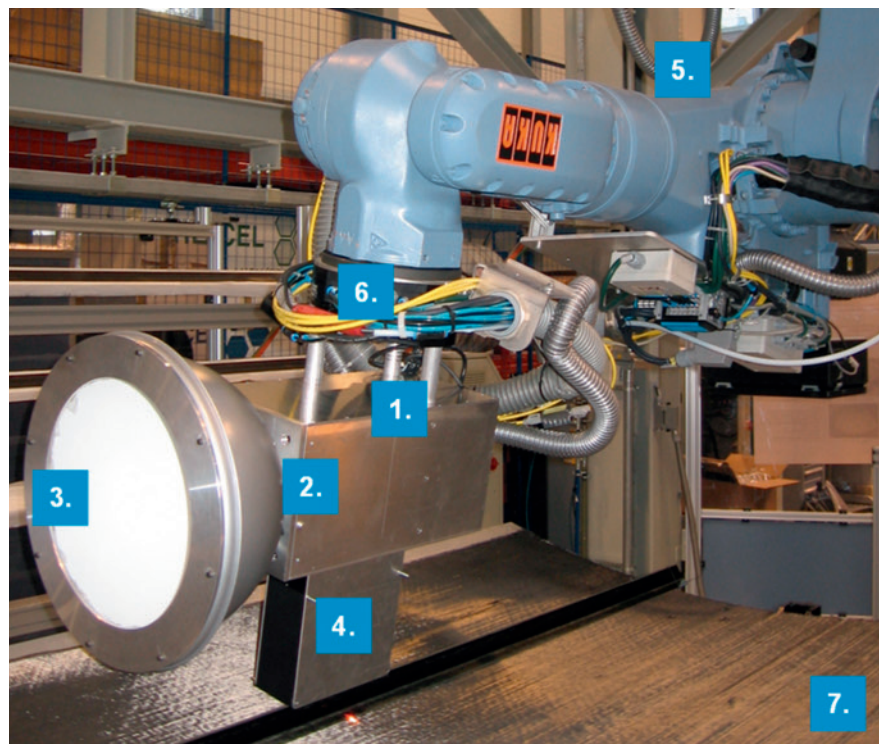
**Fig. 1. Falcon Measurement Head.** 1: robot head, 2: camera sensor and objective, 3: diffuse dome illumination, 4: laser light section sensor, 5: gantry robot, 6: automation interface, 7: test object

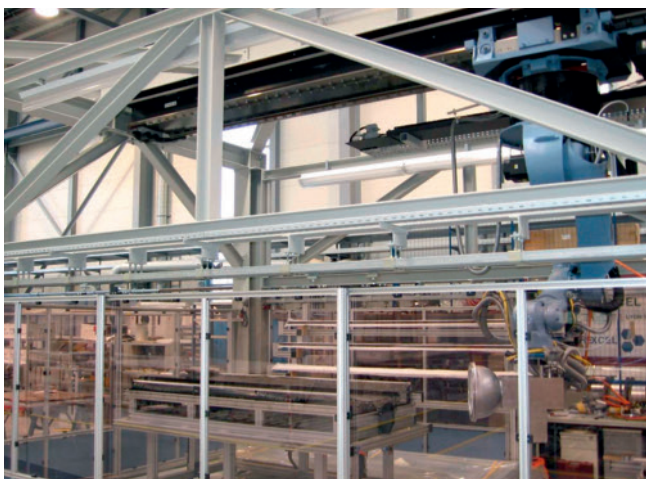
**Fig. 2. A Falcon pilot system is currently undergoing industrial trials at CTC GmbH**

Defects can thus be recognized early and scrap rates reduced, which alongside economic advantages also makes a contribution to environmental protection. A pilot system that has been integrated into a production cell with a gantry robot at CTC GmbH in Stade, Germany, is currently undergoing practical testing (Fig. 2).

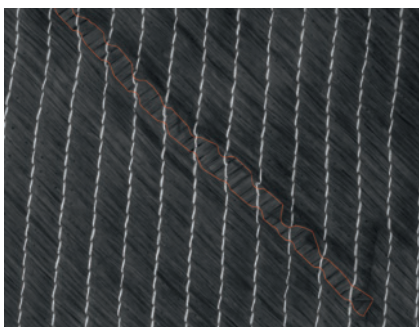
**Fig. 3. The system recognizes gaps in the structure**

Gaps are a significant defect that occurs mainly with non-crimps. A gap is formed when rovings in the upper fiber layer have been displaced or are missing. Thus the fibers in the layers beneath can be seen through the resulting openings. A newly developed segmenting technique using diffuse illumination recognizes the affected areas from the deviations in the fiber orientation (Fig. 3).

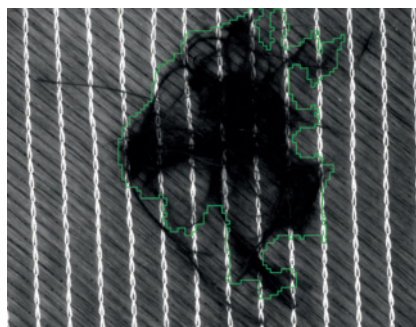
**Fig. 4. The system recognizes fuzz balls on the surface**

The recognition of foreign bodies, such as film remnants, is based on a special further development of a technique for detecting fiber abrasion, so-called fuzz balls [4] (Fig. 4). It detects when the texture in the affected surface does not show a defined preferred direction but is instead randomly orientated. This is also the case when for example film remnants are stuck to the material (Fig. 5).

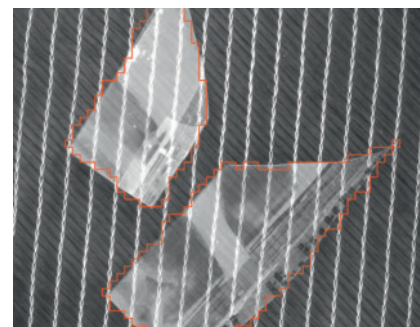
**Fig. 5. Recognition of film remnants**

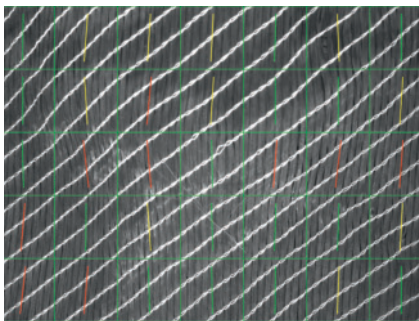
Fig. 7. Measurement and evaluation of the fiber orientation. Specified angle 90°, tolerance 1 ± 2°, tolerance 2 ± 4°, green: good, yellow: questionable, red: unacceptable

pared to the specified orientation. Based on the camera position a definite (x,y,z) position can be calculated for each measured angle. The test protocol contains the specified angle for the test area that is also linked to a global positional value. For level areas a single angle is often sufficient. If the material has been draped then various local specified angles apply. Every measured angle is automatically compared with the nearest specified angle. This means that only as many specified angles as required are stored and that the inspection process works independently from the rasterization selected for the measurement. The assessment of the fiber orientation is carried out using two tolerances in respect of the allowed deviation from the specified angle and results in a classification as good, questionable or unacceptable (Fig. 7). Green angles are rated as good, yellow as questionable and red as unacceptable. A detailed description of the technique can be found in [5, 7]. ■
